ATTACHMENT A

FORMER CARTER CARBURETOR SITE

NOVEMBER 16, 1993 SAMPLING EVENT

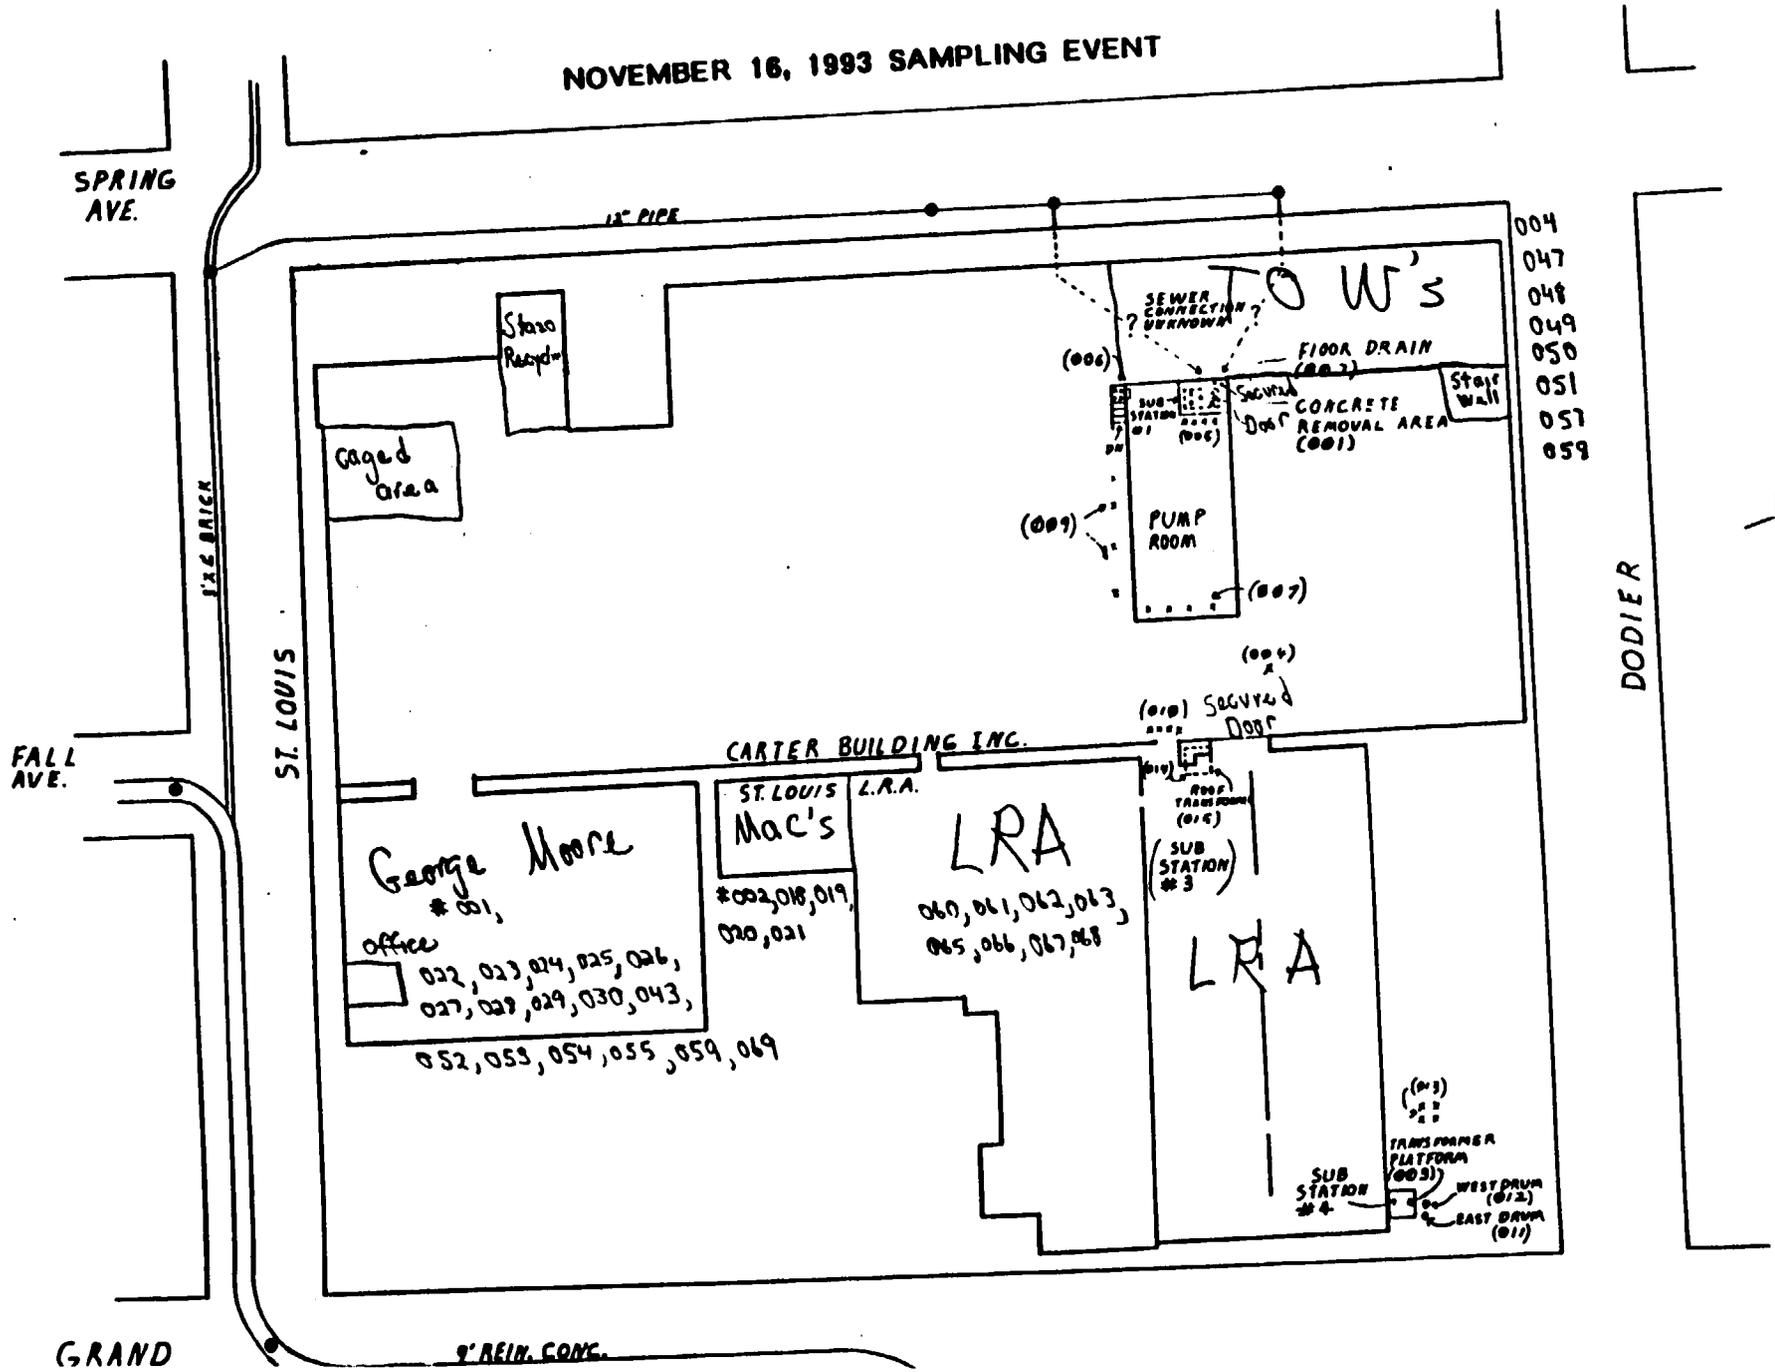
1st floor

FLOOR DRAIN  
(002)

CONCRETE  
REMOVAL AREA  
(001)

022, 023, 024, 025, 026,  
027, 028, 029, 030, 043,

052, 053, 054, 055, 059, 069

#002, 018, 019,  
020, 021

060, 061, 062, 063,  
065, 066, 067, 068

TRANSFORMER  
PLATFORM  
(003)

WEST DRAIN  
(012)

EAST DRAIN  
(011)

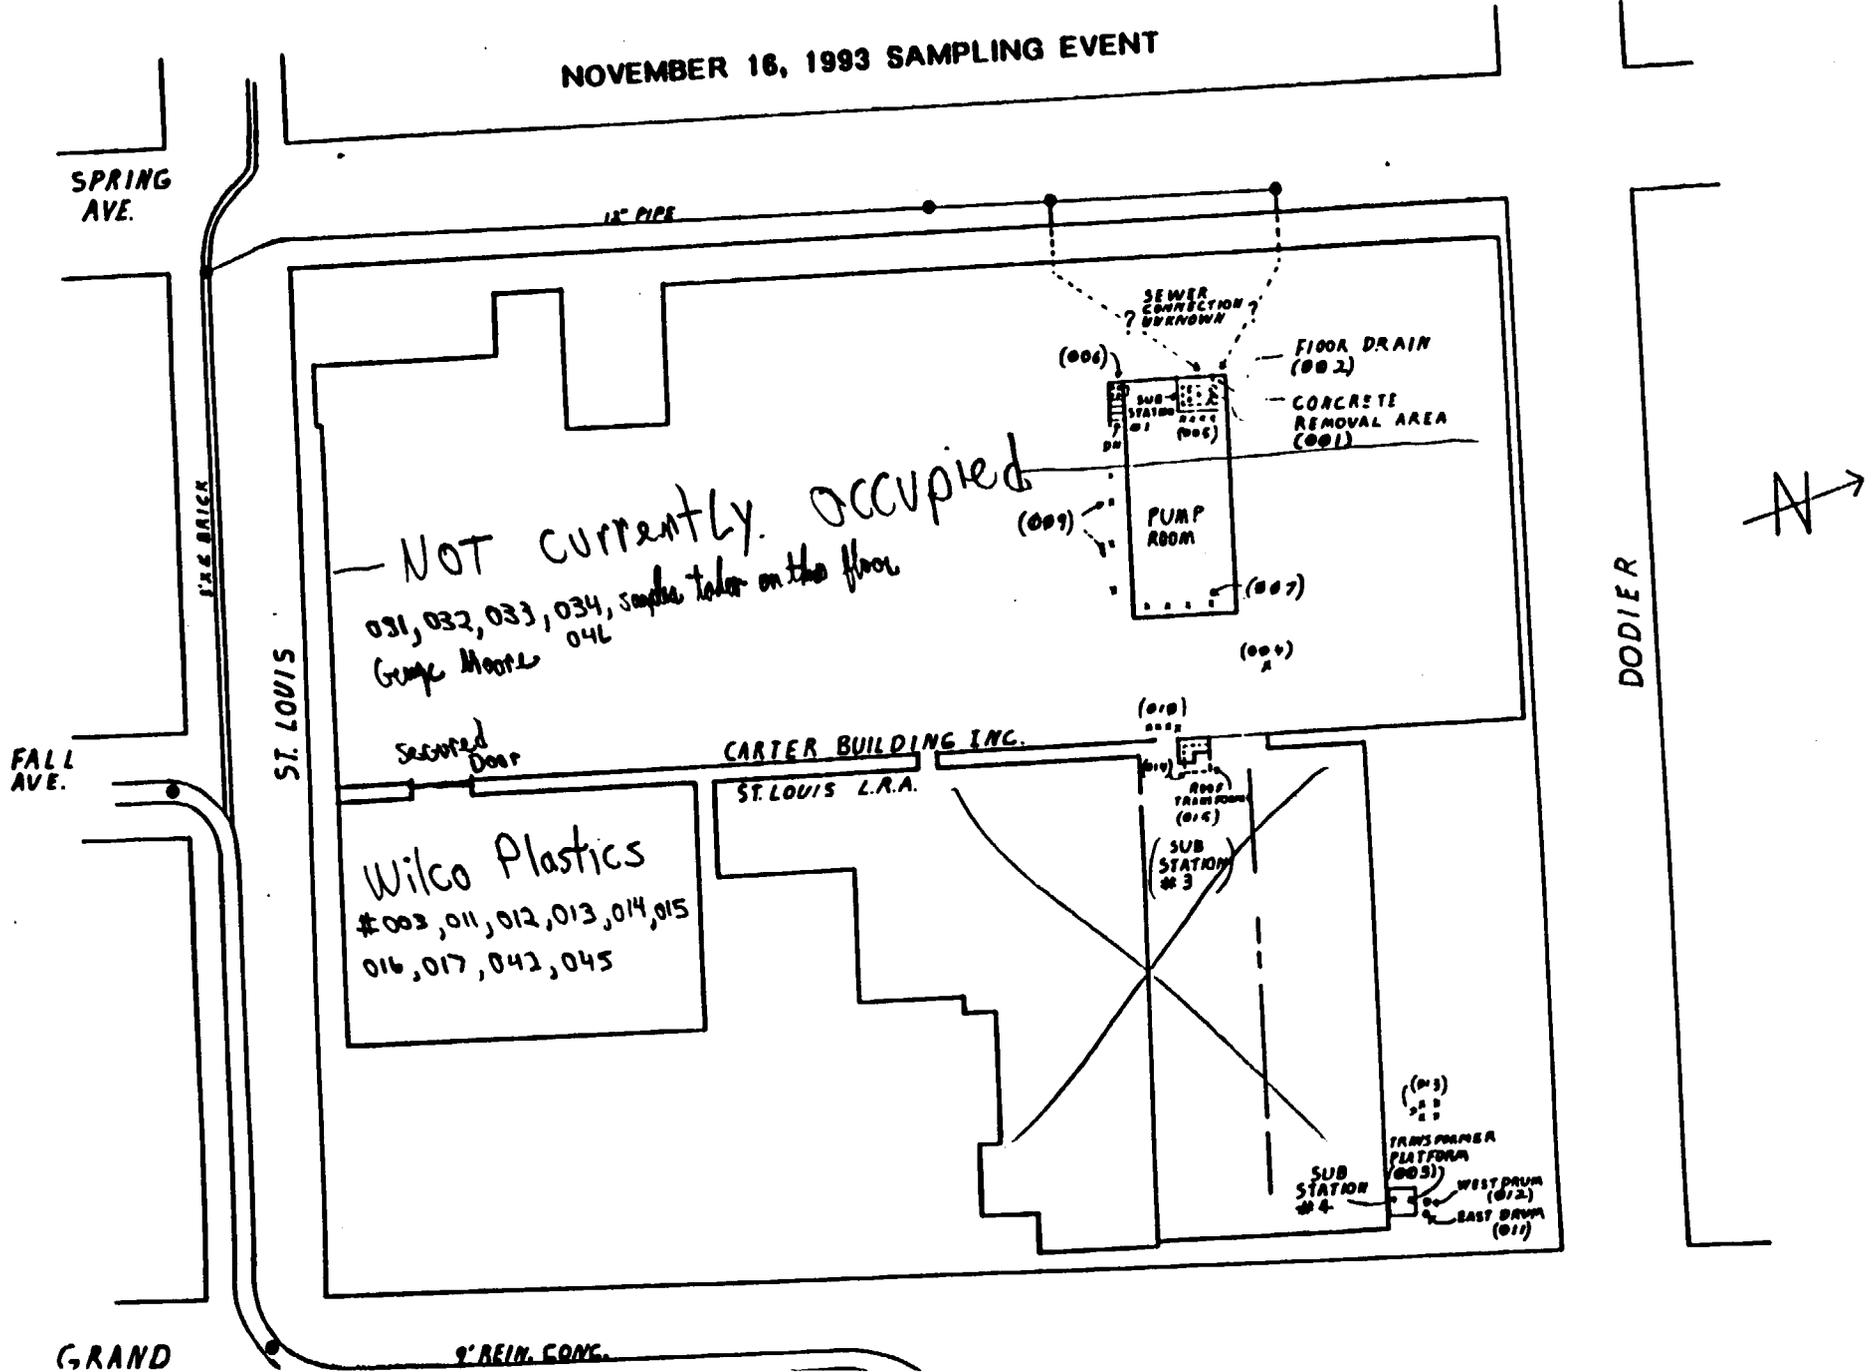
nd Floor

NOT currently occupied  
031, 032, 033, 034, samples taken on the floor.  
Gump Moore 046

Wilco Plastics  
#003, 011, 012, 013, 014, 015  
016, 017, 042, 045

TRANSFORMER PLATFORM (003)  
SUB STATION #4  
WEST DRUM (012)  
EAST DRUM (011)
